DURABILITY OF FRP COMPOSITE RETROFITS AFTER SERVICE IN A SUBARCTIC ENVIRONMENT

Sandra Milev (Ph.D.CE)¹, David G. Goodwin Jr.², Jovan Tatar¹

¹University of Delaware | Center for Composite Materials | Department of Civil and Environmental Engineering

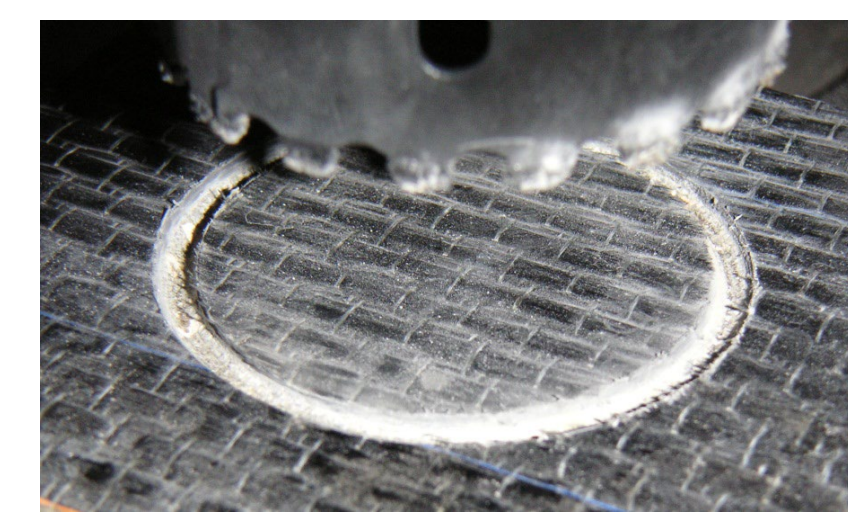
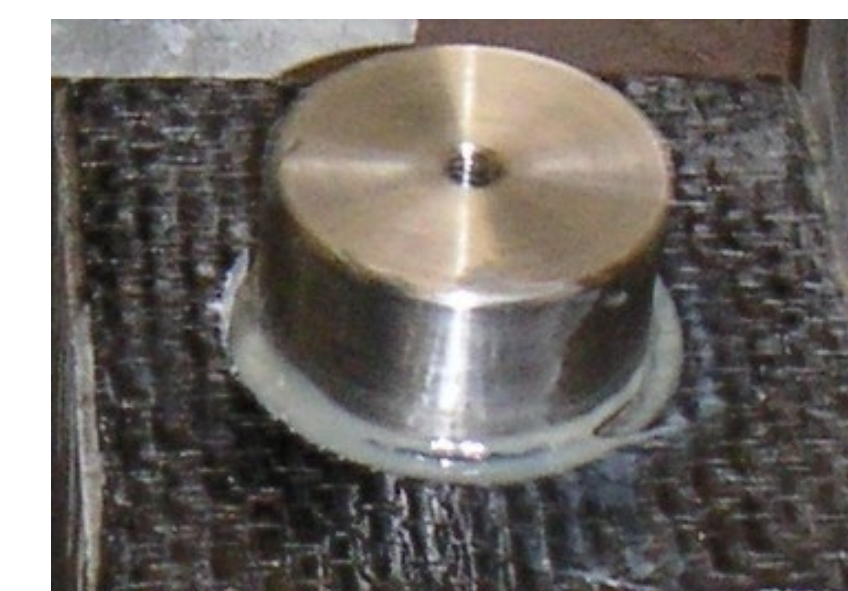
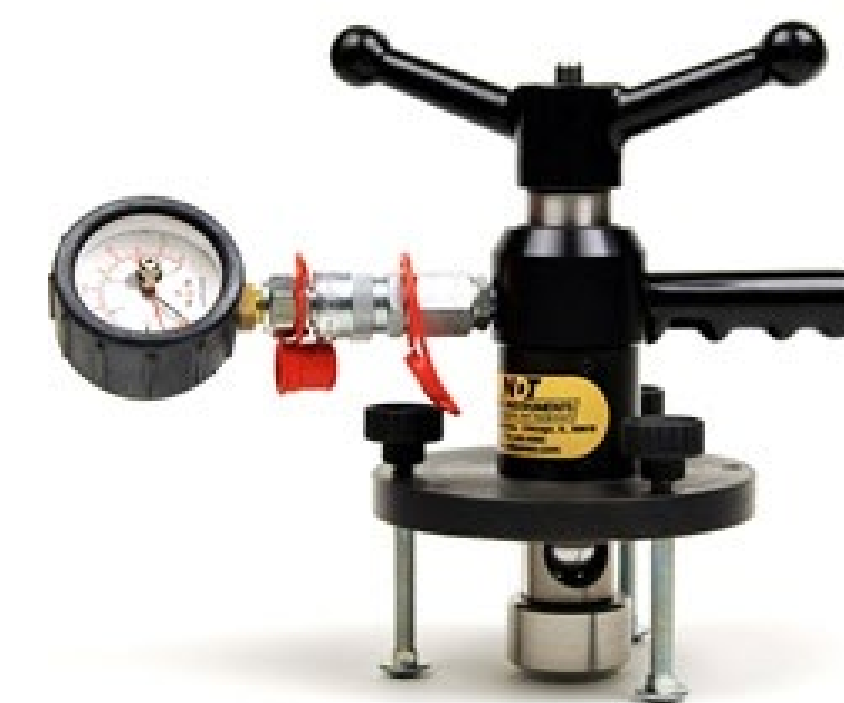
Pull-off bond tests

American Concrete Institute guidelines (ACI 440.2R) require min bond strength of 1.4 MPa

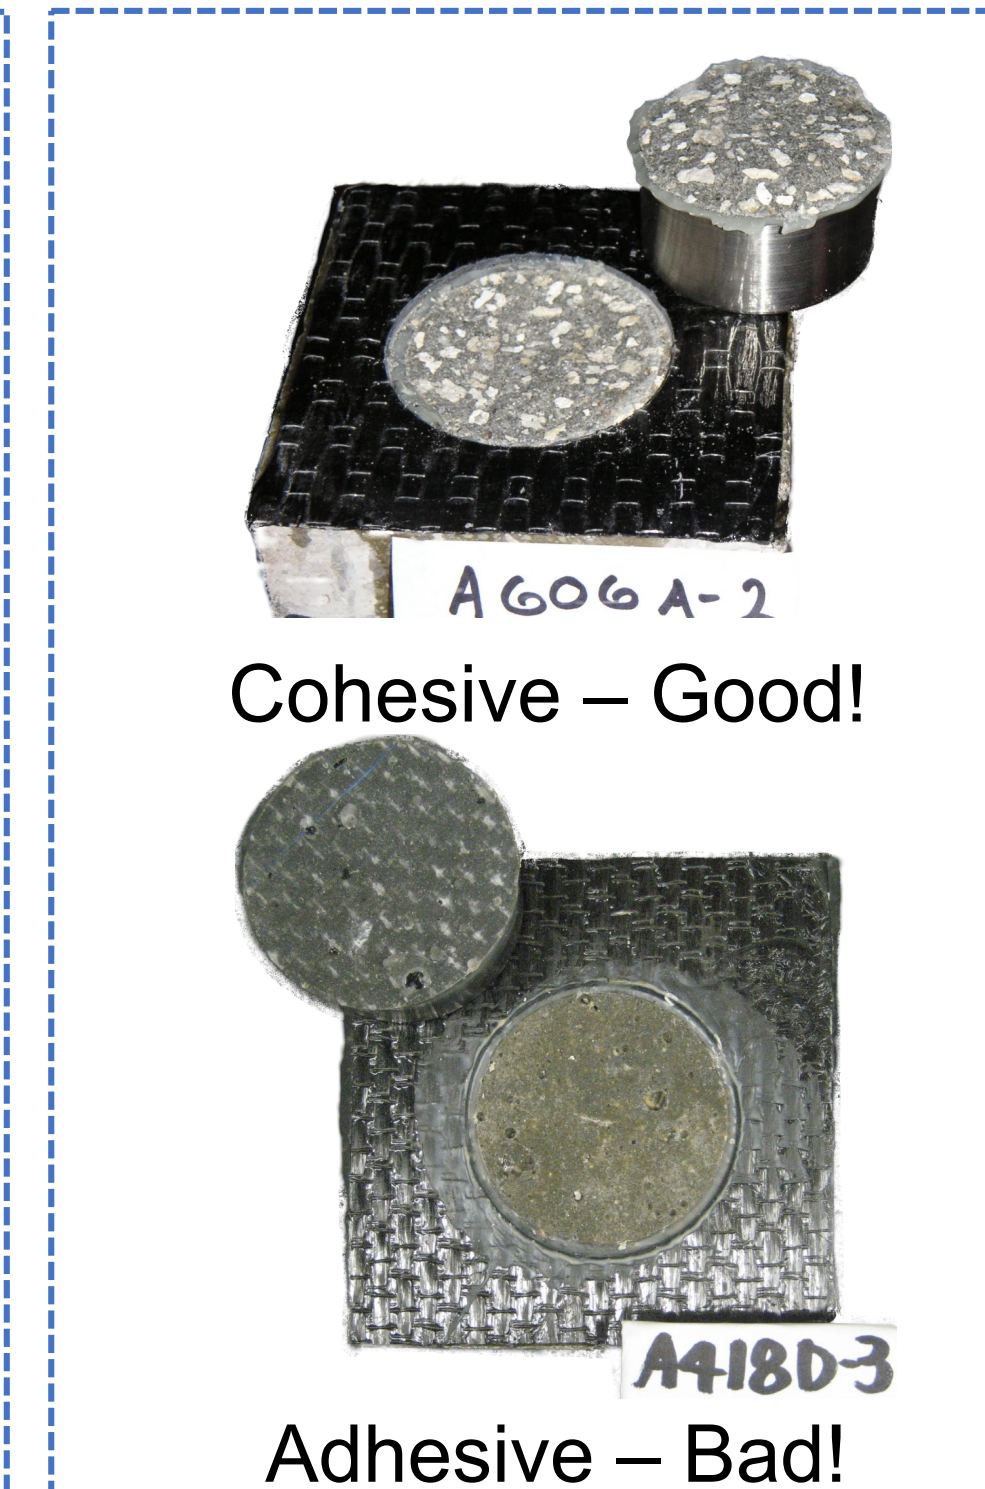
The main failure mode was a cohesive failure (in the concrete) indicating good adhesion. However, adhesive failure was observed for the exterior column at TSIA which suggests that some degradation of the CFRP may have occurred in the subarctic climate of Anchorage.

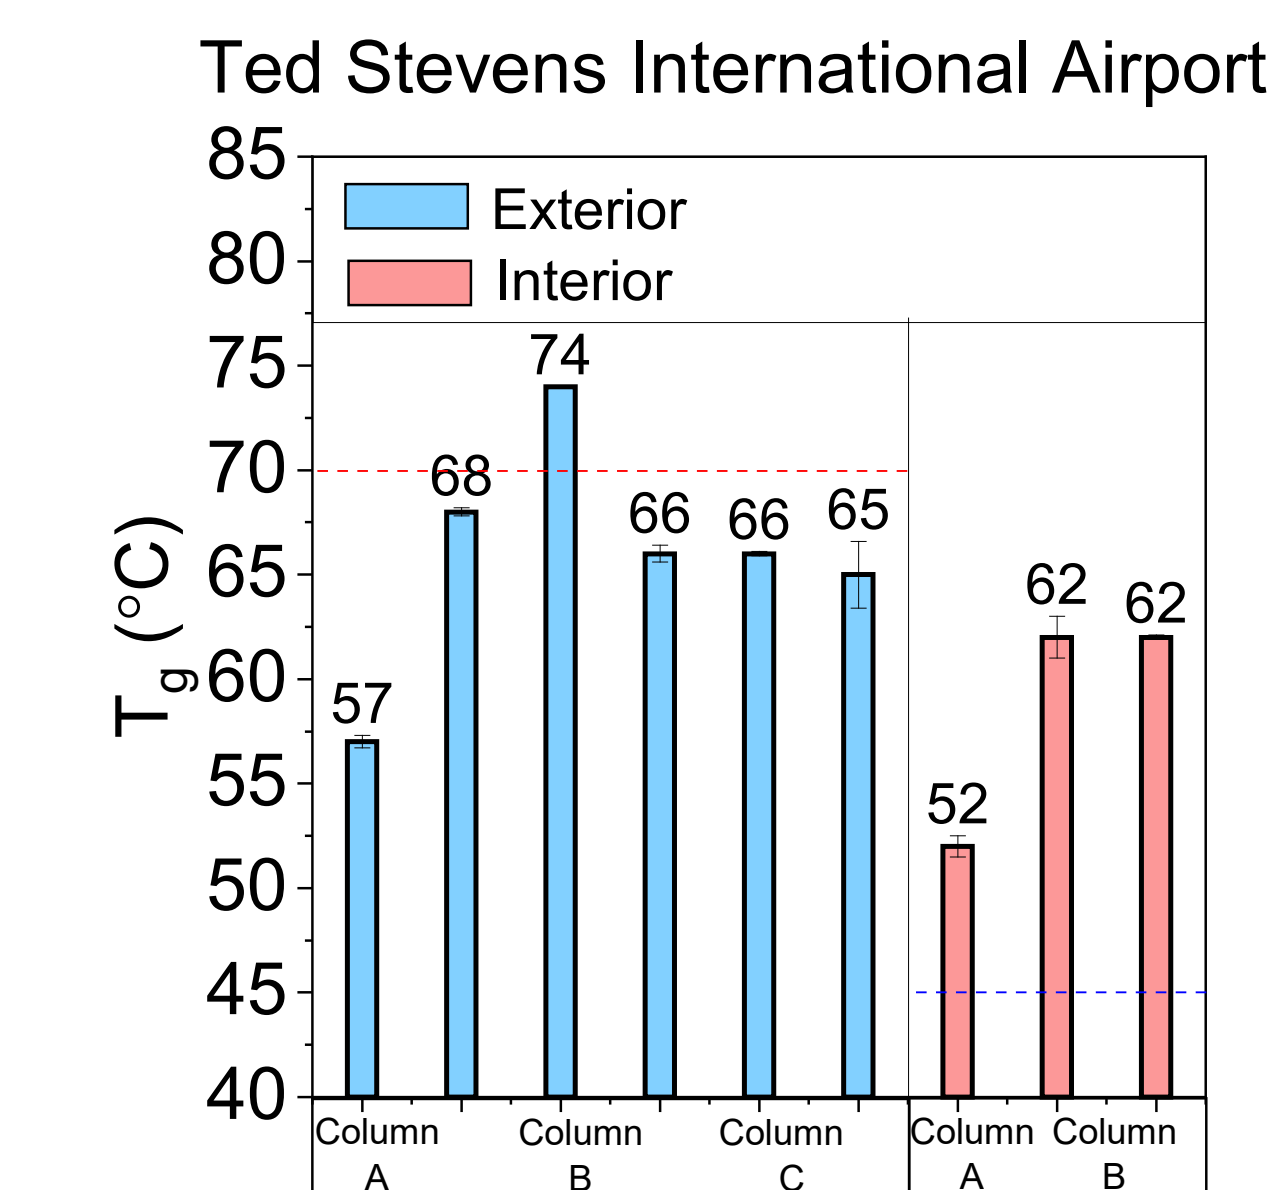
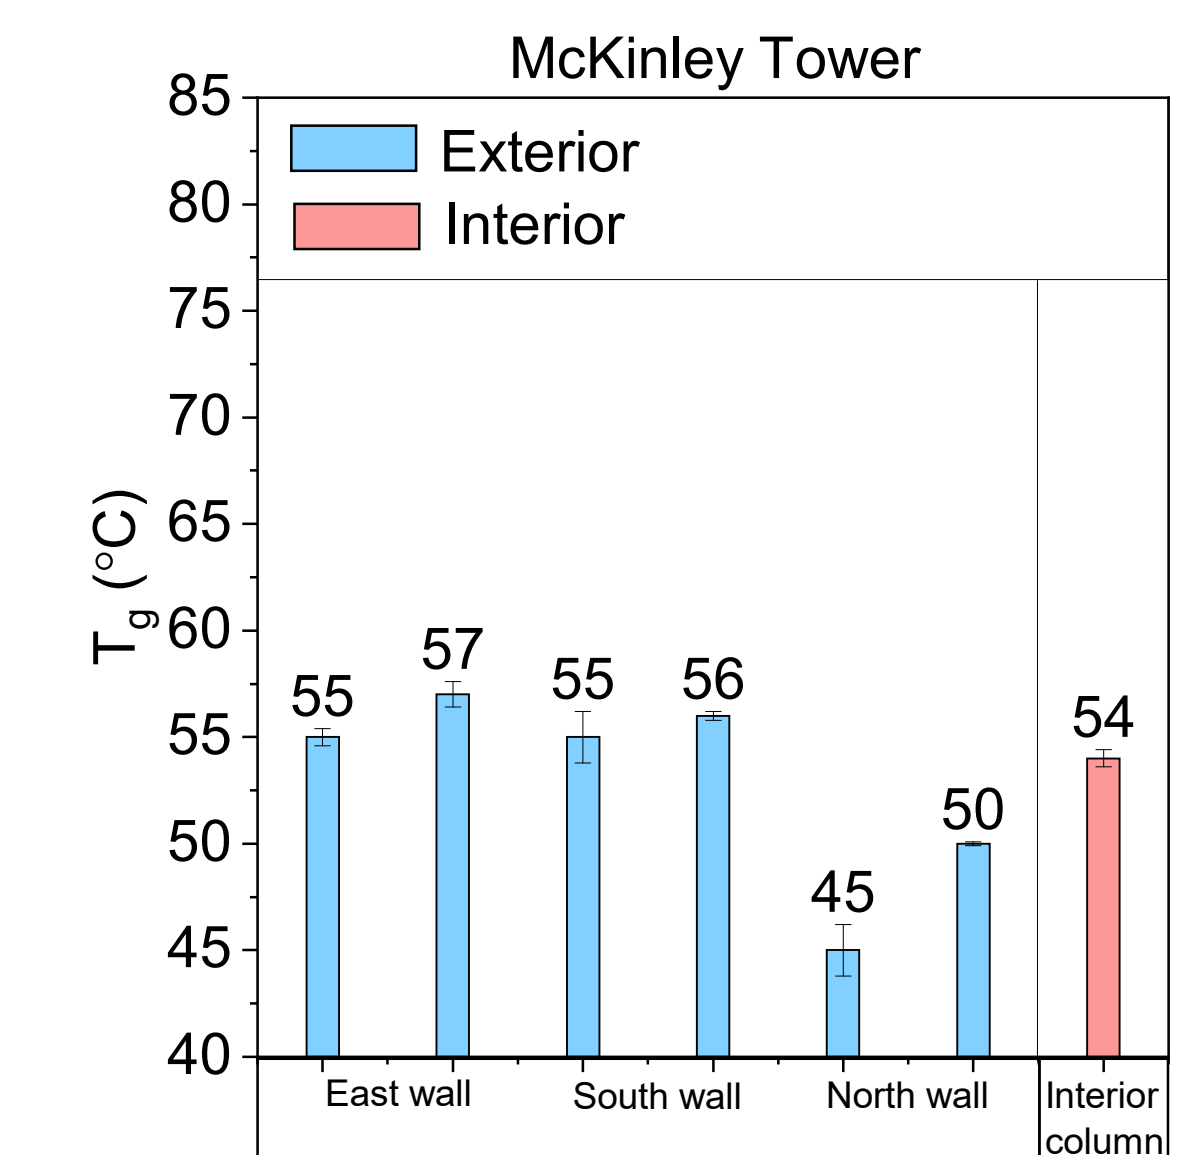
Differential Scanning Calorimetry

- At TSIA, most exterior samples had significantly higher T_g values than the maximum T_g values measured on the interior samples.
- At MKT, exterior T_g was below ACI 440.2R recommendation

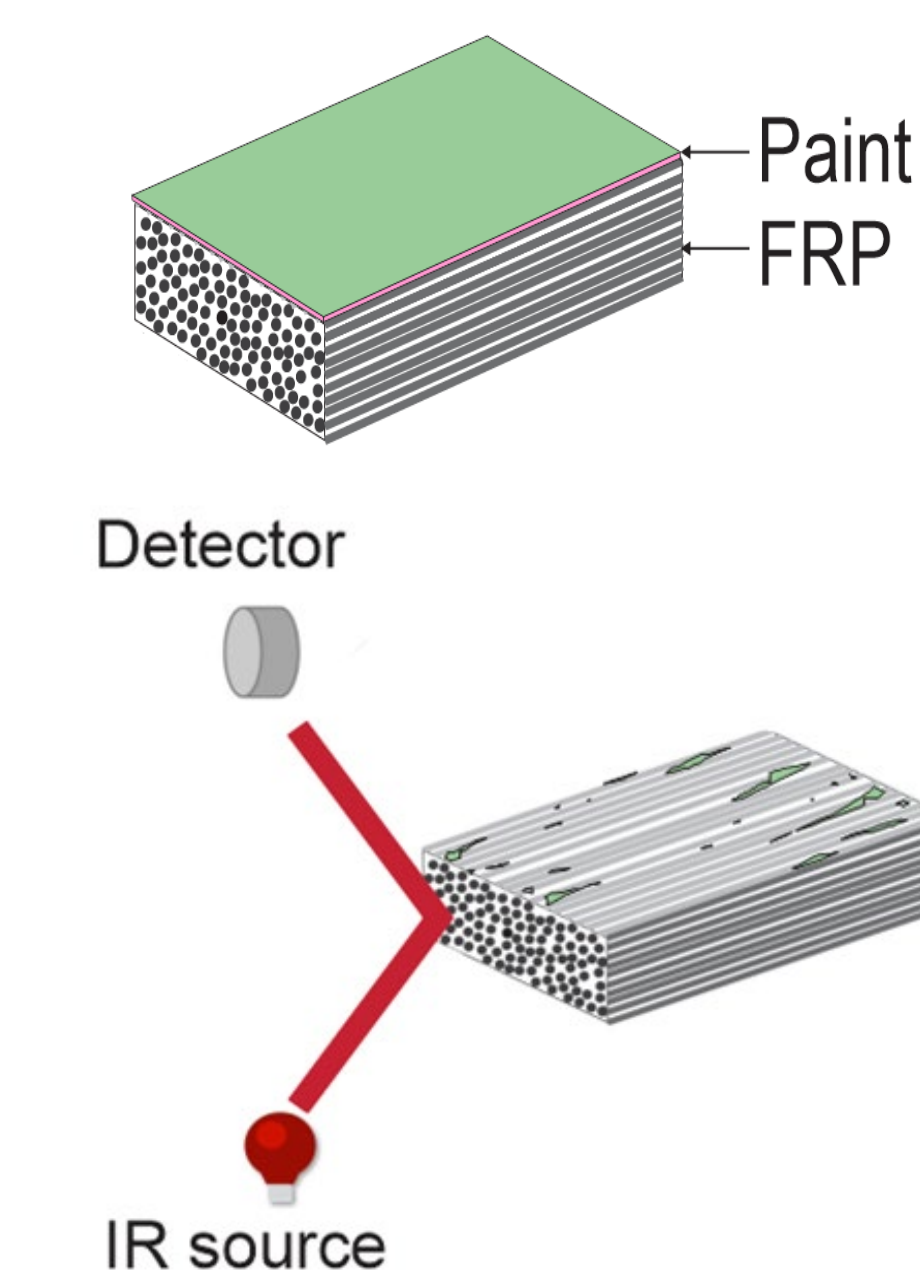
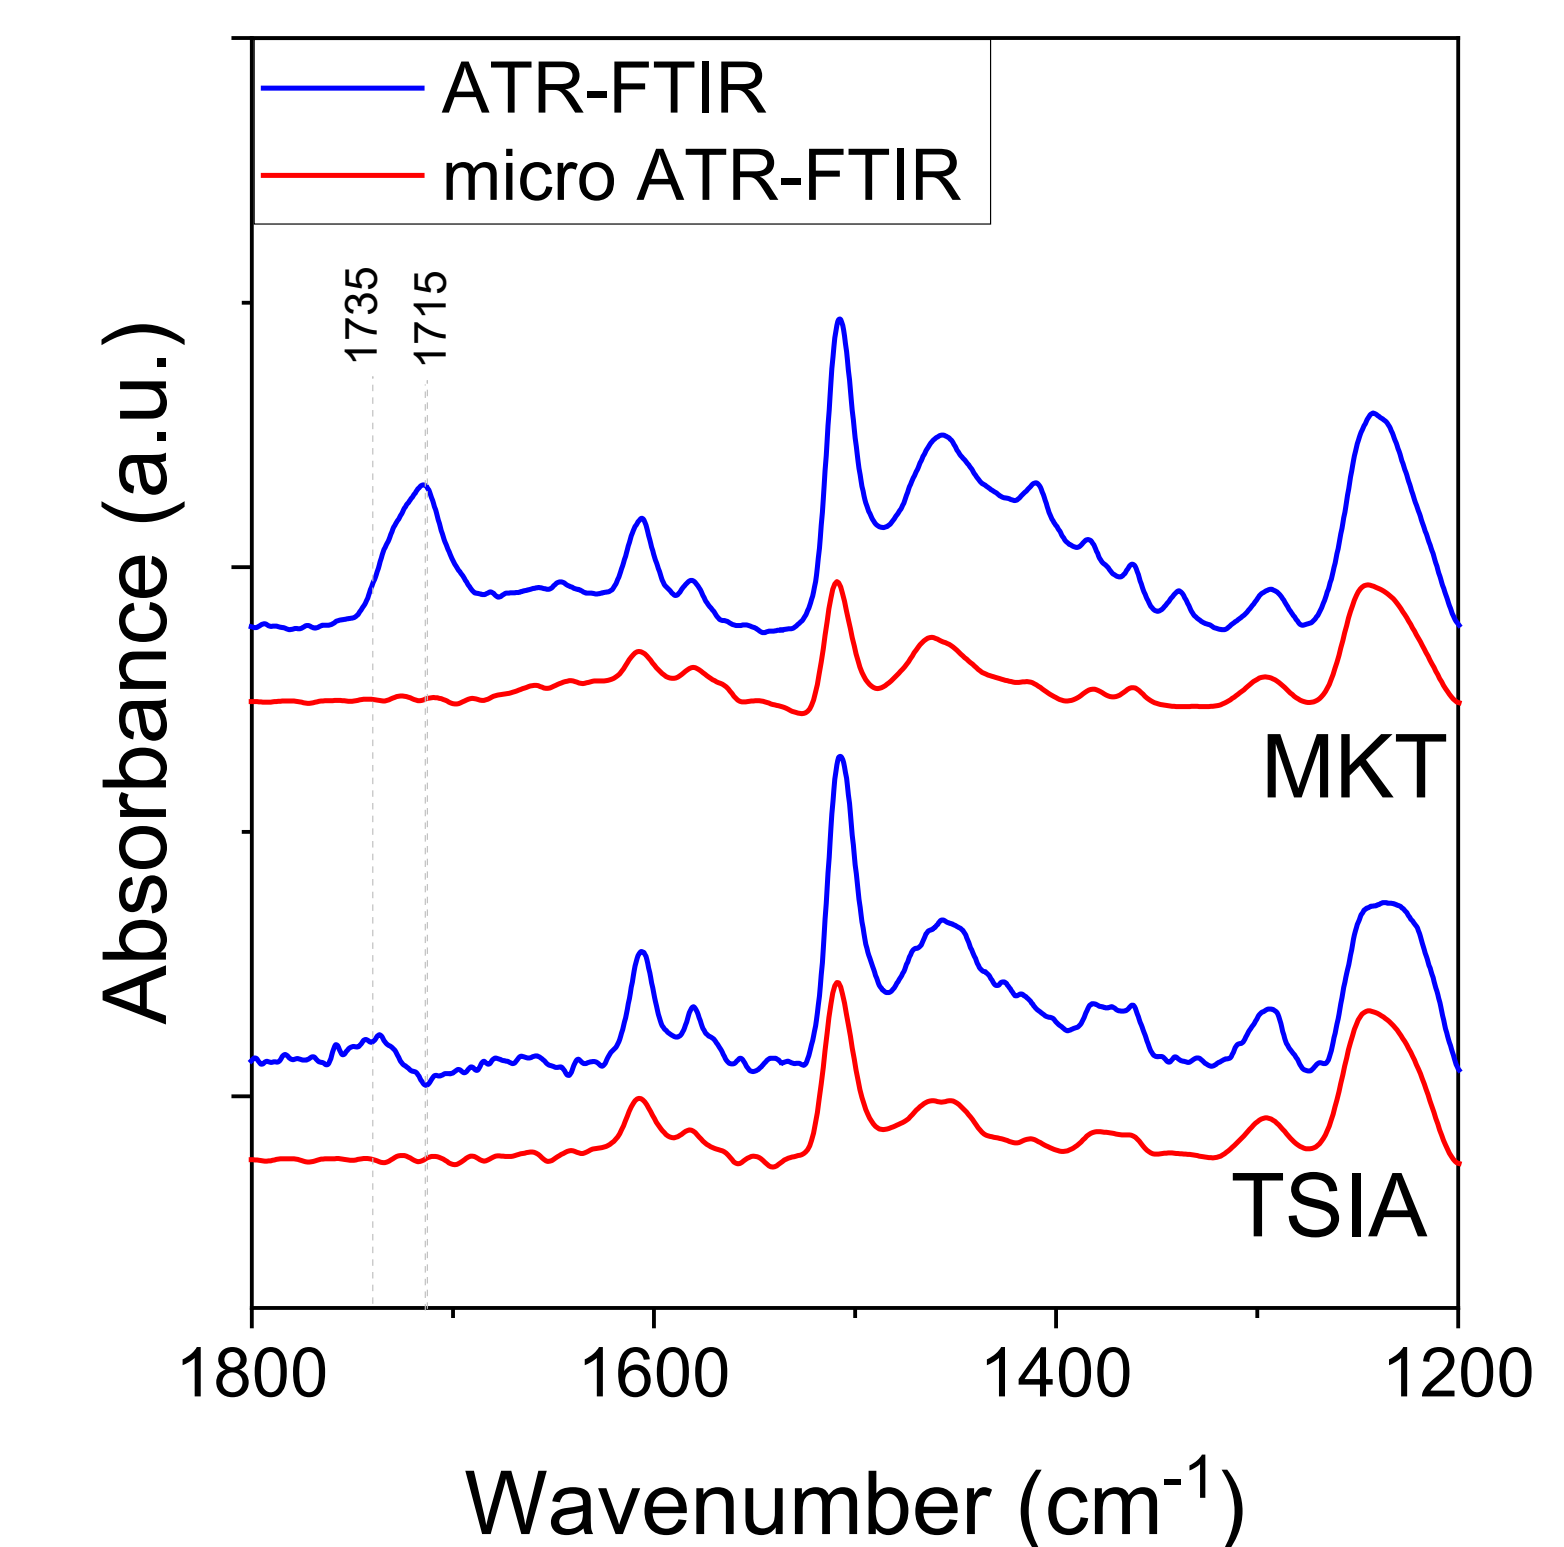
FTIR Spectroscopy

- ATR-FTIR: Presence of 1720 cm^{-1} related to chemical degradation present at MKT.
- Micro-FTIR on the cross-section: if any degradation occurred it was limited to the surface layer of less than 100 microns.
