DURABILITY OF FRP COMPOSITE RETROFITS AFTER SERVICE IN A SUBARCTIC ENVIRONMENT

Sandra Milev (Ph.D.CE)¹, David G. Goodwin Jr.², Jovan Tatar¹

¹University of Delaware | Center for Composite Materials | Department of Civil and Environmental Engineering

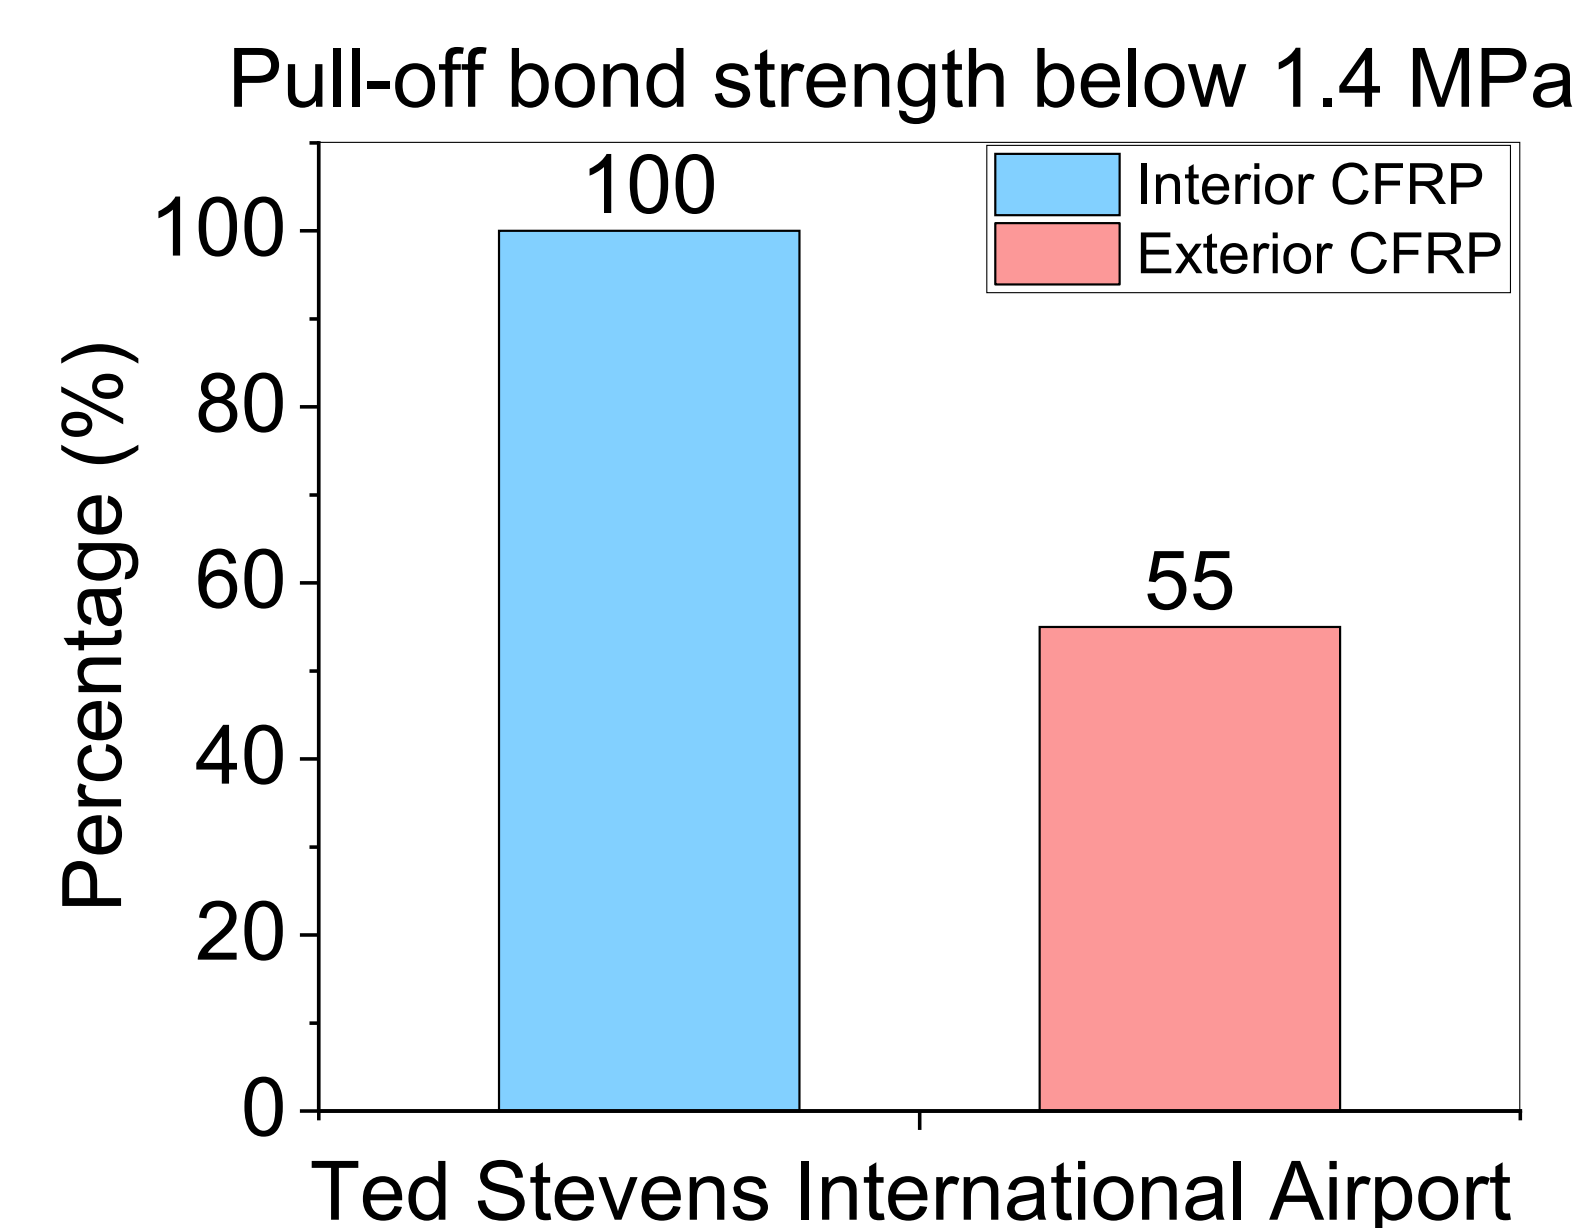
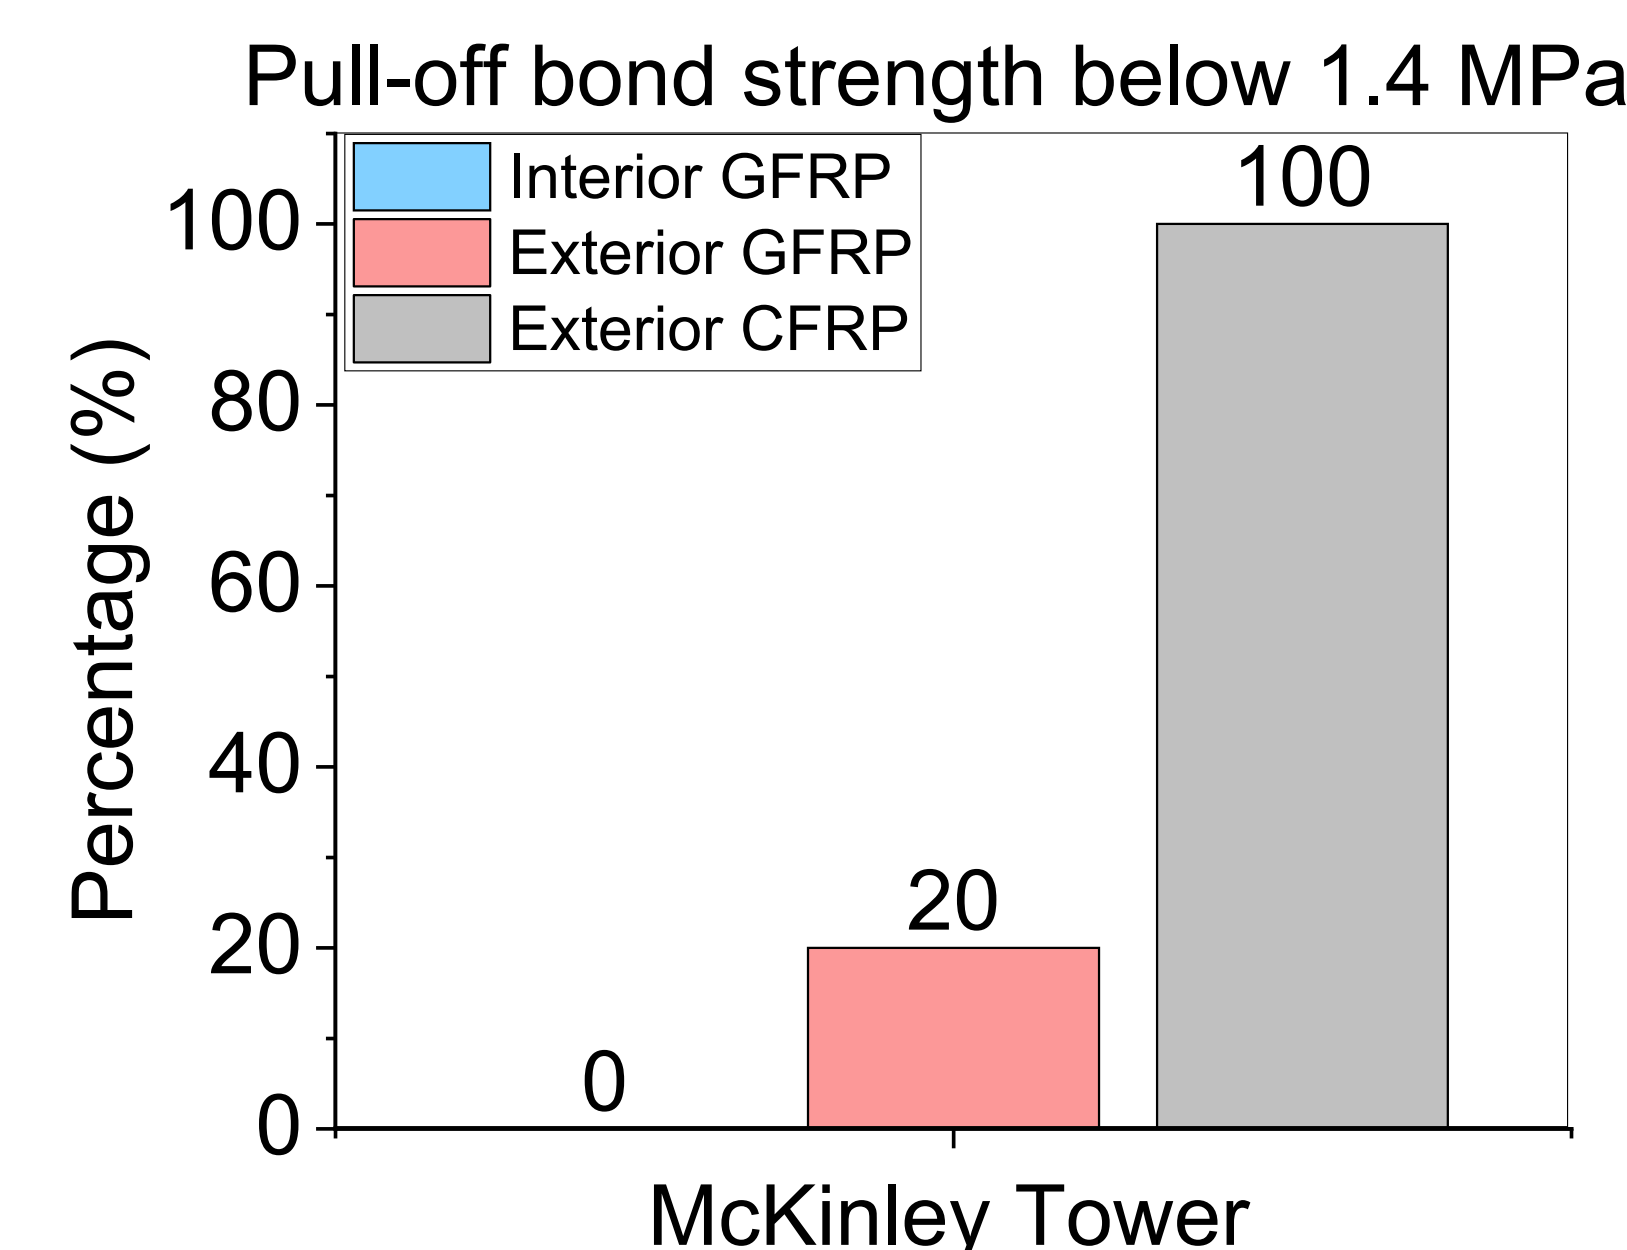
The main failure mode was a cohesive failure (in the concrete) indicating good adhesion. However, adhesive failure was observed for the exterior column at TSIA which suggests that some degradation of the CFRP may have occurred in the subarctic climate of Anchorage.
