MECHANICAL BEHAVIOR OF UV-CURED COMPOSITE STEPPED LAP ADHESIVE JOINTS

Shagata Das, (Ph.D.C.E.)^{1,2}, Prof. John W. Gillespie, Jr.^{1,2}, Prof. Harry W. Shenton, III², Dr. Jovan Tatar^{1,2}
University of Delaware | Center for Composite Materials¹ | Department of Civil and Environmental Engineering²

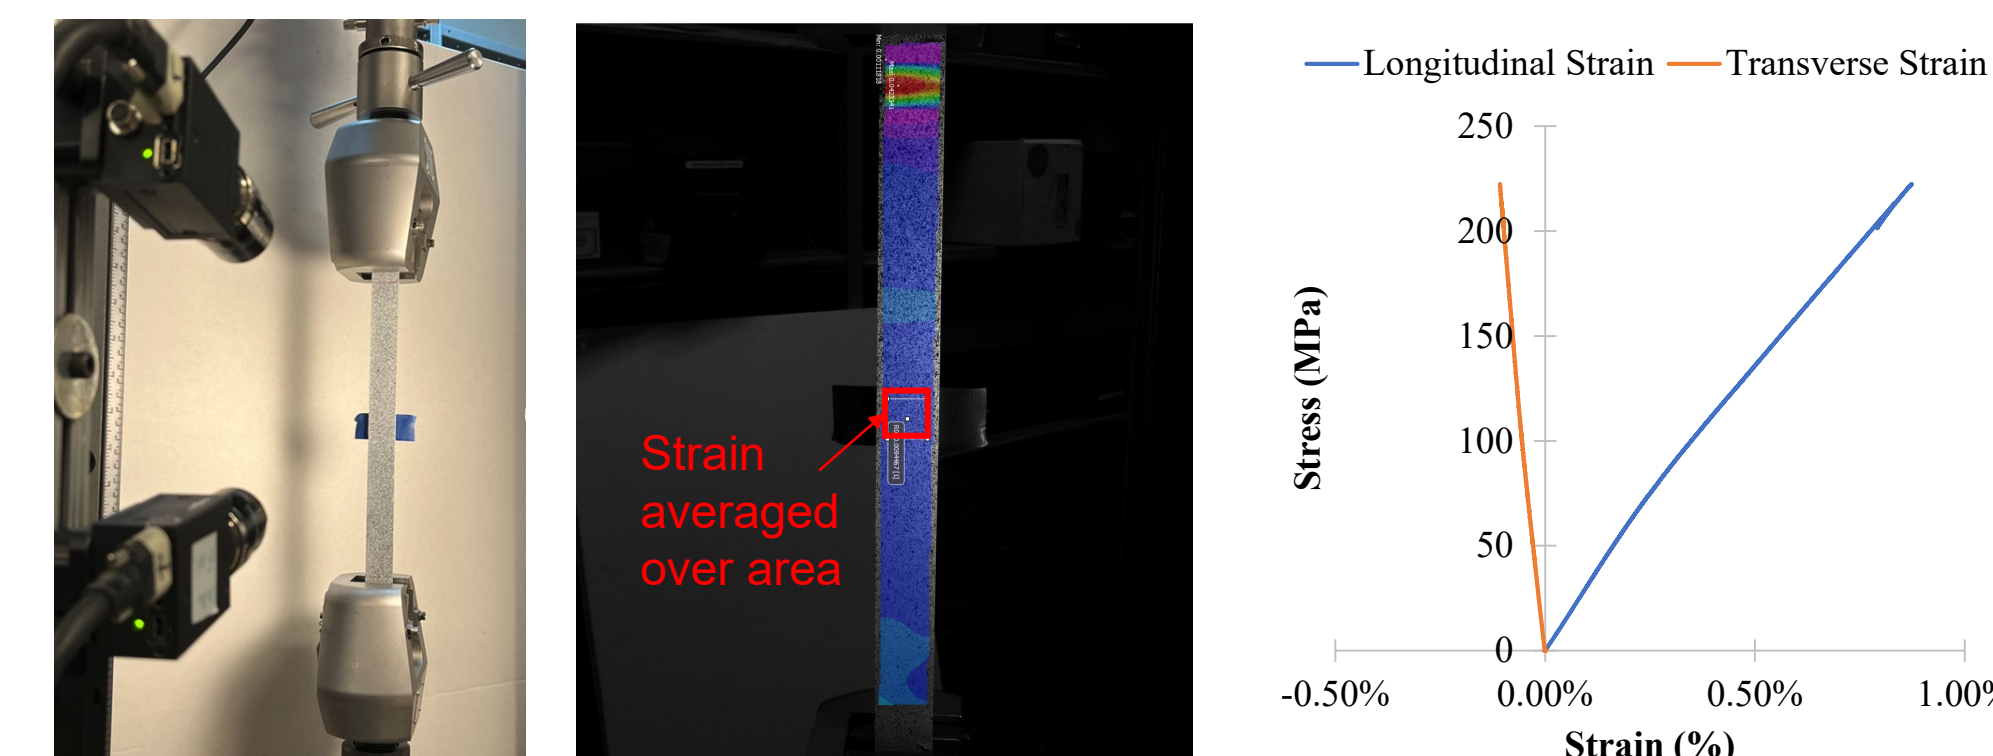
Tensile Testing

- Displacement rate of 1.27 mm/min
- 3D Digital Image Correlation (DIC) system to record strain data
- Longitudinal and transverse strains were averaged over an area of 1.9 x 1.9 cm

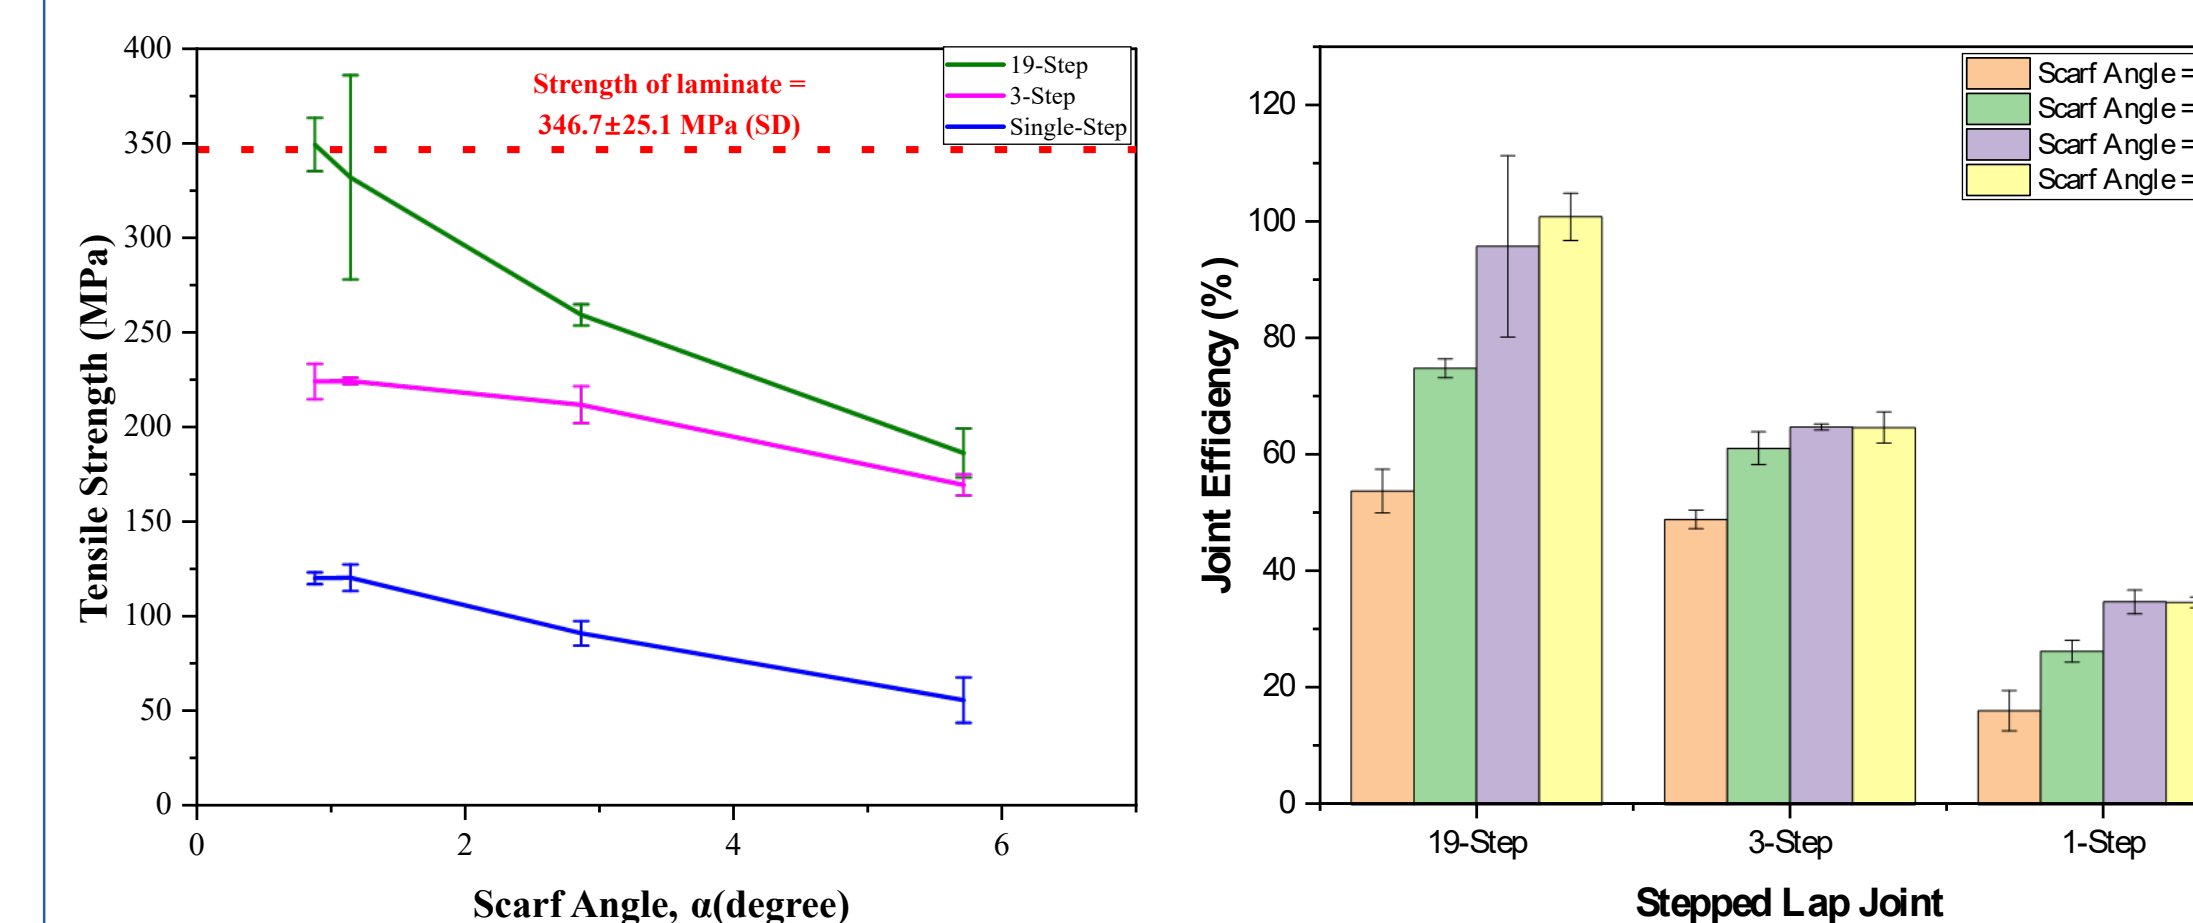
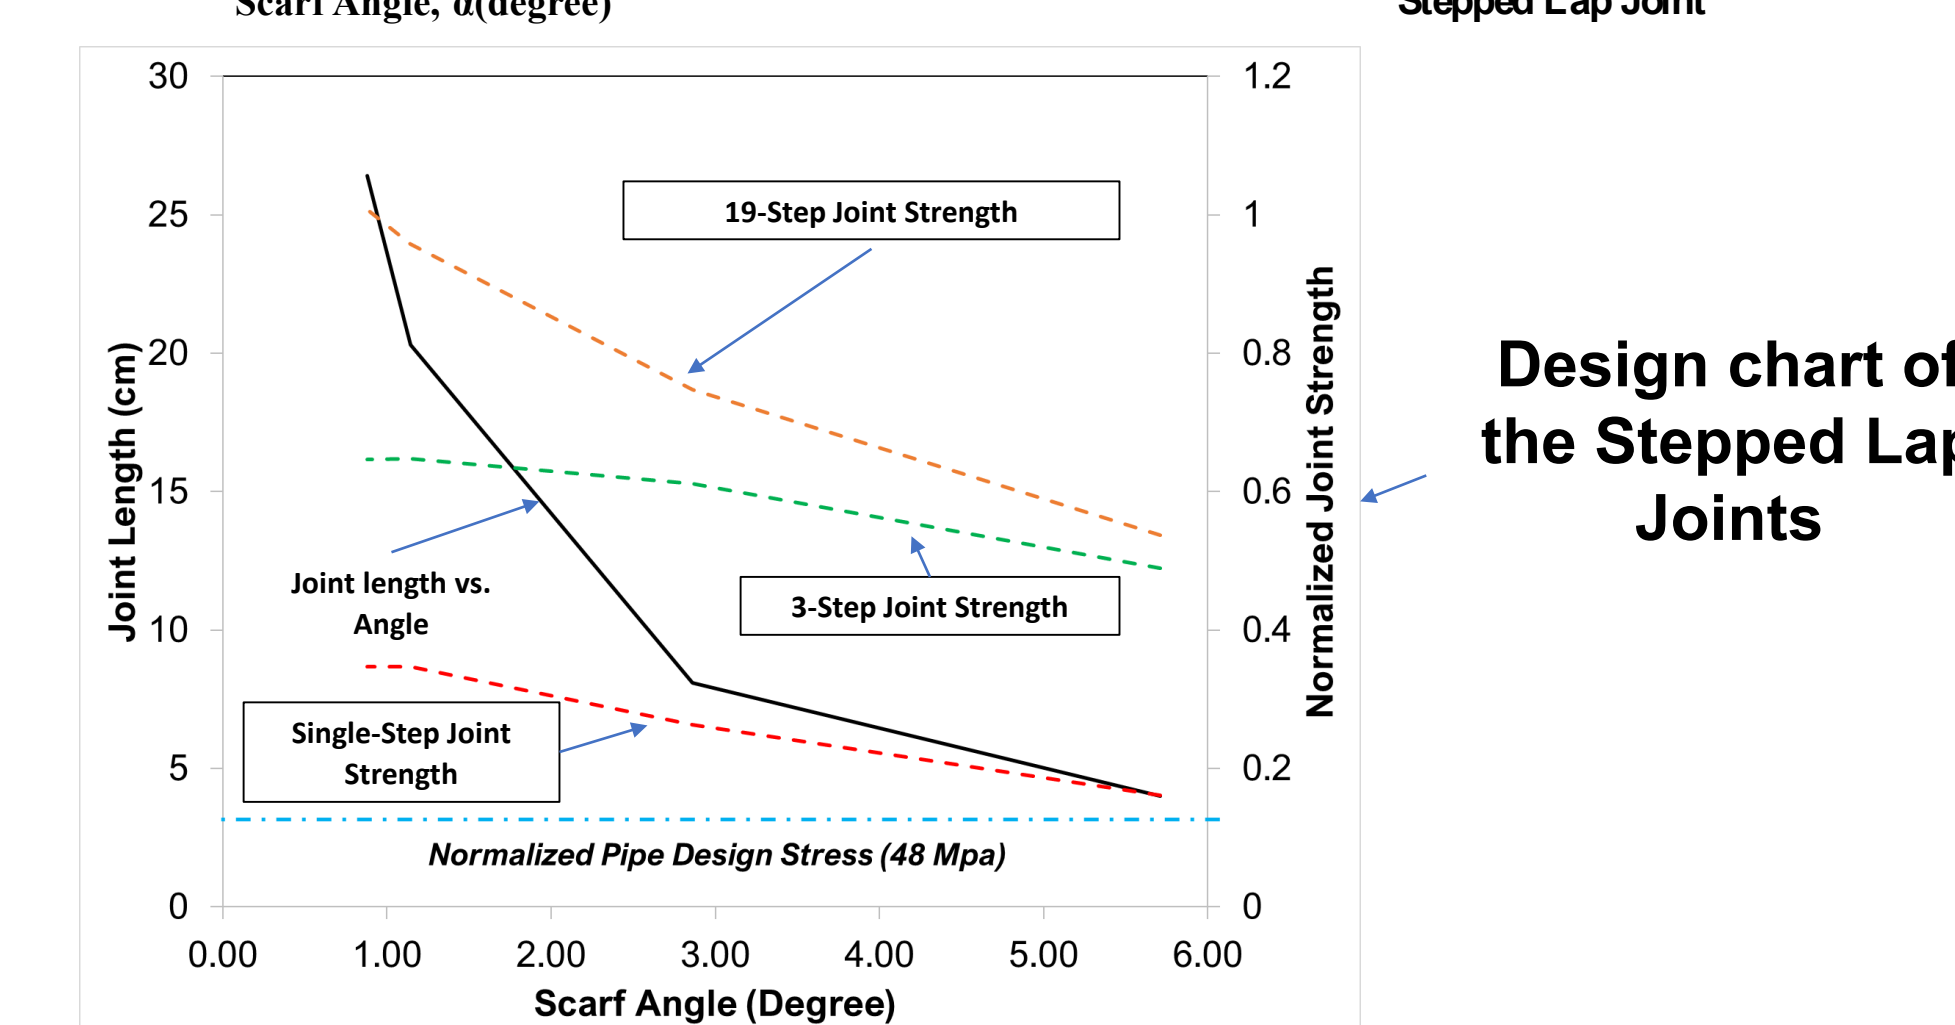
Tensile Testing Result

- Tensile strength of the joint increased as the scarf angle decreased
- Joint efficiency of 100% was achieved
- Tradeoff between joint length and strength needs to be considered

- The joint tensile strength is inversely proportional to the scarf angle
- The efficiency of tested joint configurations ranged from 15 to 100%
- 19-step joints exhibited evidence of fiber rupture
- A progressive failure was observed
